Building a Sustainable Ethical Culture	OPS02 – F12 Photo Report	
	Revision: Issue 1	Author: S. Eidecker
	Release date: 3/1/2016	Approved: A Valdevitt

Audit ID:	156-032793-001	Audit date:	2026/04/01
Factory name:	SHANGHAI TAHUI KNITTING MILL

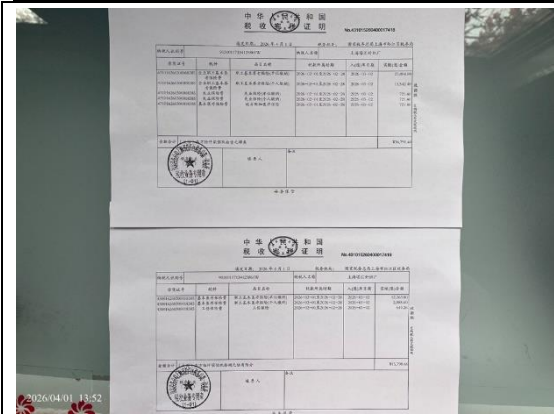
NC-5.5 Insufficient social insurance.

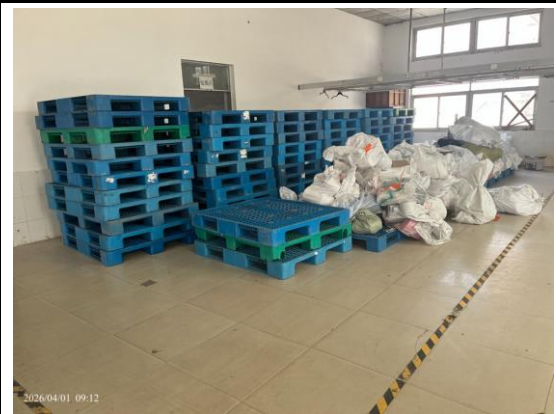
NC-7.1 Goods were stored against the wall.

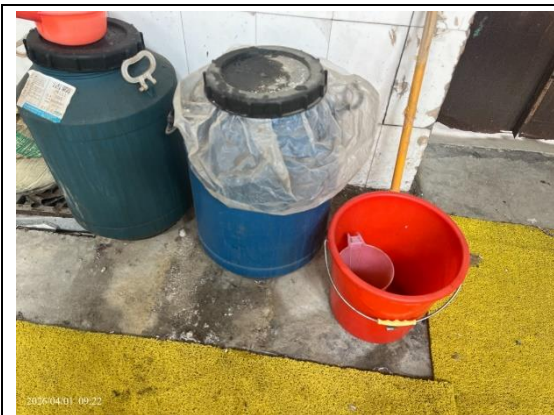
NC-7.7 Chemical without anti-leakage equipment, label, SDS.

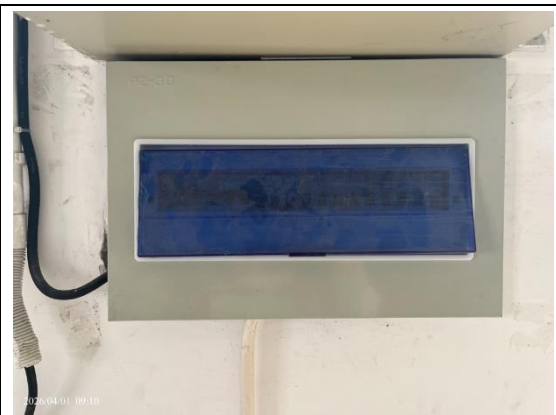
NC-7.9 No warning sign was posted for sampled electricity switch boxes.

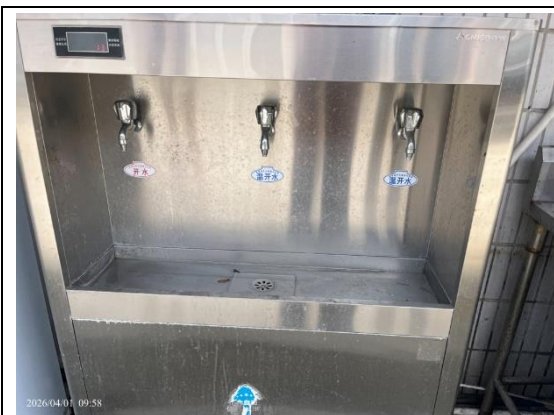
NC-7.9 No high temperature warning sign posted nearby the drinking water device.

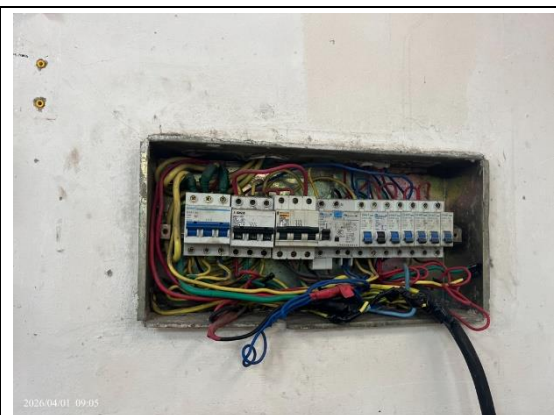
NC-7.13 Sampled electrical switch boxes were found without protective covers.

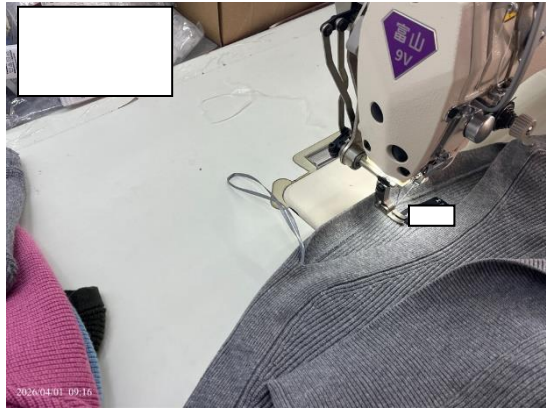
Nil
<p>NC-7.17 Finger protect ring was not installed for sewing machines.</p>
